Oct 2018

# North Queensland Study into Water Damage from Cyclones

**Project partners: IAG and SUNCORP**

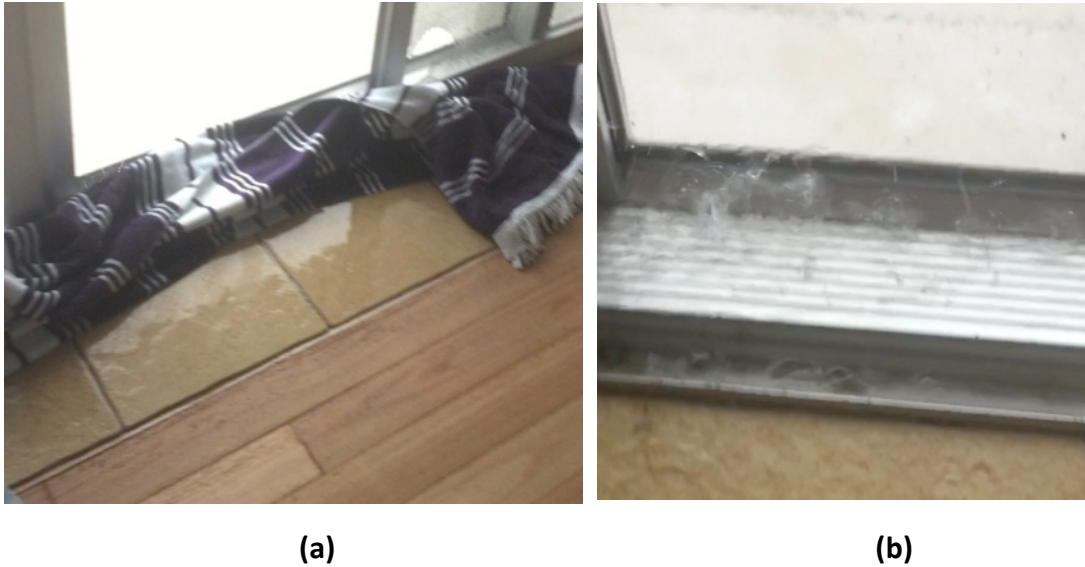
Videos taken during TC Debbie by residents showed that considerable volumes of water came through windows and sliding glass doors, under swinging doors, and through light fittings and ceilings. In many cases, the water entered buildings that had no damage to the building envelope. The rain caused damage to vulnerable elements such as plasterboard wall linings and ceilings; floor coverings; and personal belongings. In multistorey buildings, the rain percolated down through the building for a number of storeys below the original point of entry.

Figure 1 (a) Towels placed in front of large windward wall windows to control large amounts of water, and (b) water spaying into living room from under the door (CTS TR63)

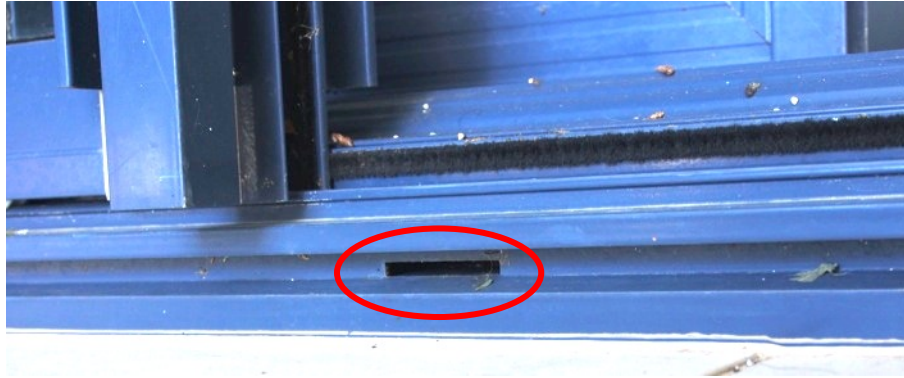
Weep holes in windows or glass sliding doors (Figure 3) are designed to allow condensation and minor leakage around seals to pass from the inside to the outside of the building. However, in high winds, differential pressure forces horizontally driven rain on windward walls through weep holes (i.e. in the opposite direction intended in design) and through other gaps in the building envelope.

Figure 3 Weephole in glass sliding door frame

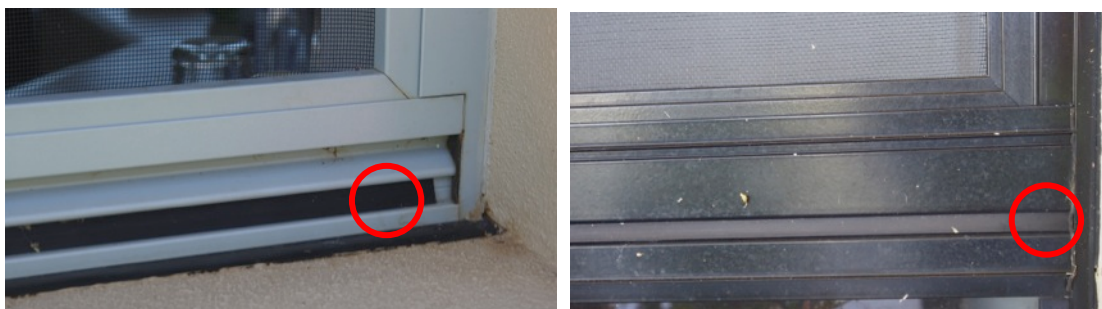
However some people mentioned, who were in either apartments or houses, they had no water or only a small amount of water enter through their sliding windows during TC Debbie. Typically, the windows without significant water ingress had weep holes that were covered by external rubber strips. Figure 3 (a) shows a window from a house and another in a larger apartment building with rubber seals over the weepholes that performed well. The windows and glass sliding doors in another apartment building, Figure 3 (b), had an external baffle that concealed the weepholes; only a small amount of water leaked through them. This door also had a step that would have assisted in reducing water into the unit from water that pooled on the balcony near the bottom of the door.

(a) Sliding windows with rubber flaps over weepholes

*Figure 4 Windows and glass sliding doors that prevented wind-driven rain entering the building*

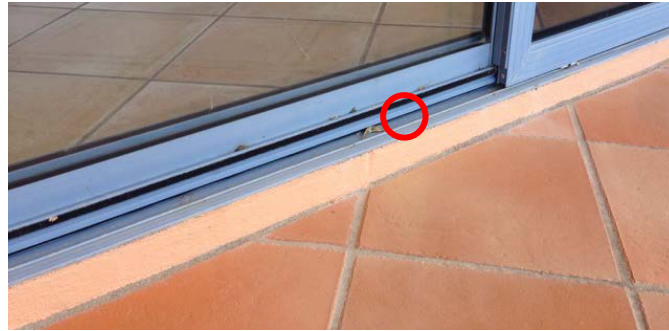
(b) Sliding glass doors with baffle that concealed the weepholes on an apartment balcony

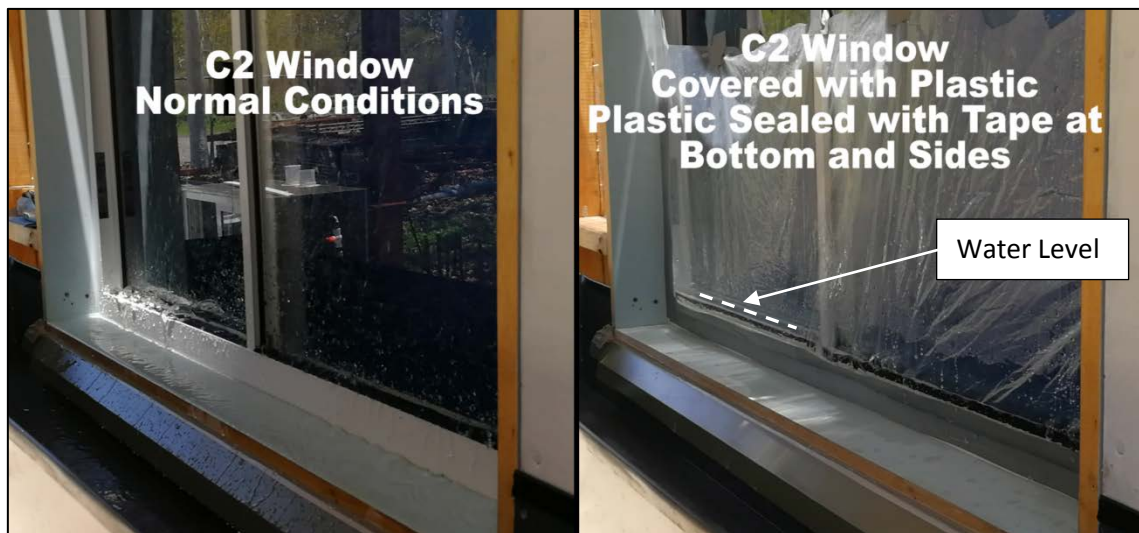
Various mitigation strategies such as taping over the weep holes were trialed. The only configuration that greatly reduced the amount of water ingress was by using a strip of plastic sheet taped on the inside of the window sill (i.e. outside of WDRS). This strip of thin plastic increased the height of the window sill, caught the water and allowed it to drain back out of the house via the weep holes. Figure 6 shows results side by side during a pressure peak of a fluctuating pressure trace. A significant amount of water is being pushed through the seals and over the sill of the window on the left side, while the water is constrained by the plastic lining on the right side. This was a similar result for the sliding door tests.

Figure 6 Side by side views of normal window and window with the Plastic sheet sill extension during a pressure peak

**Simple measures such as storm shutters on the exterior or the plastic sheet sill extension on the inside face of the window can greatly reduce the amount of driven rain entering our homes.**
