Oct 2018

# North Queensland Study into Water Damage from Cyclones

**Project partners: IAG and SUNCORP**

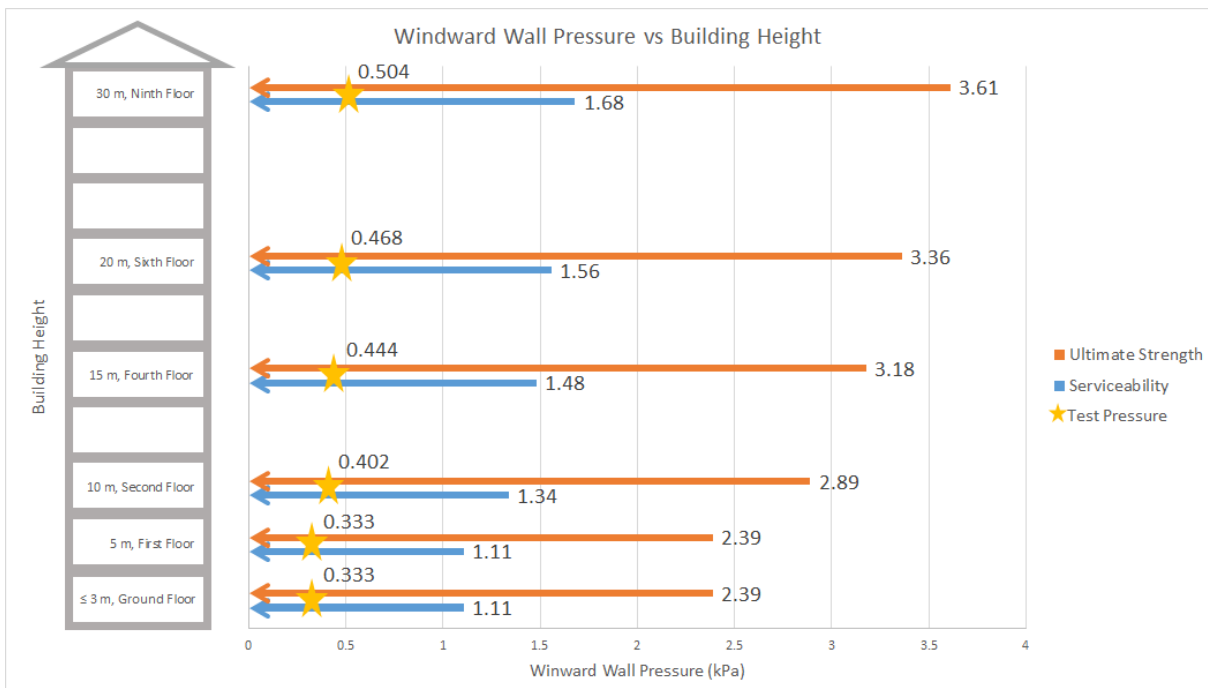
There is a large range of window sill designs in the marketplace; some window sealing and drainage systems are simple, while others are very complex. All windows must satisfy performance criteria in AS 2047 (Standards Australia, 2014), which includes a test to exclude water penetration at the prescribed test pressure. However, **this test pressure is only one-third of the serviceability design pressure (Serviceability design means that the building remains functional during and after this loading).**

Figure 2 Relationship between ultimate strength design pressure, serviceability design pressure and the test pressure for the Australian Standard water penetration test showing how small the test pressure is in relation to the Serviceability design.

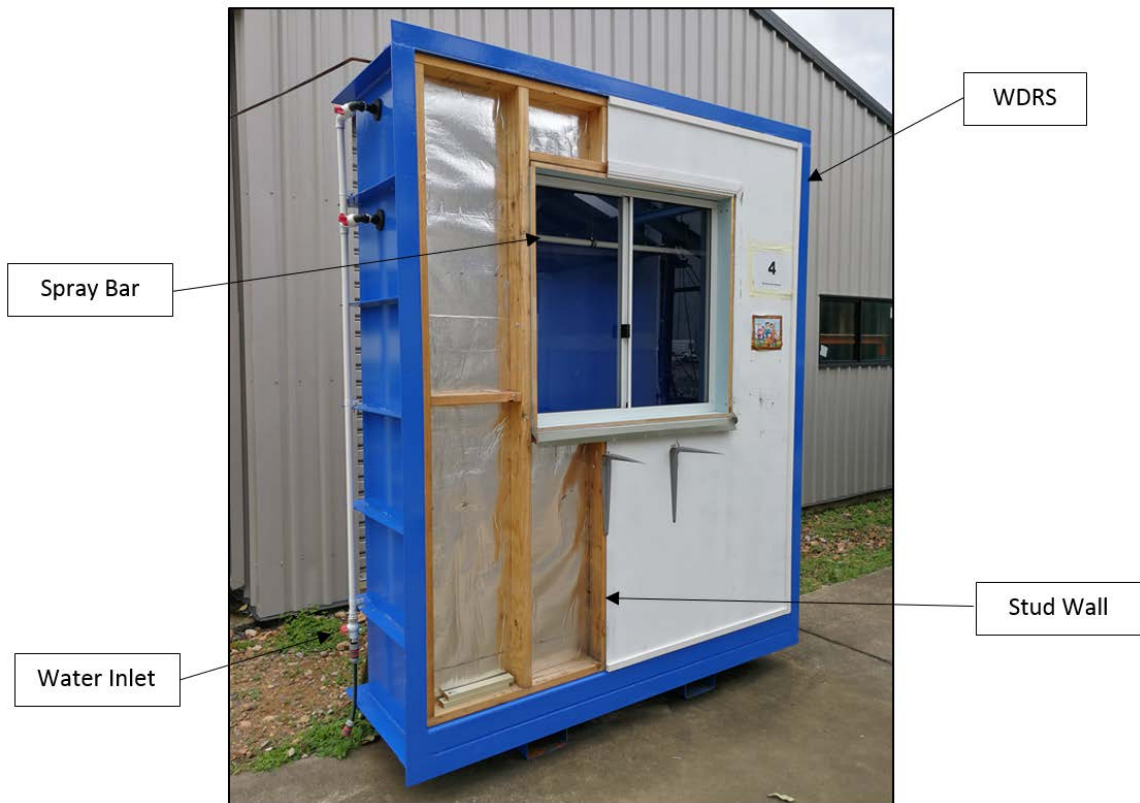
During the testing, all the modern window and door specimens tested were compliant with the AS 2047 rain flow rate and static test pressure of approximately 300 Pa standard, and did not let uncontrolled water into the inside of the building. However, for the fluctuating pressures encountered during wind storms the windows and door leaked, a lot.

Figure 5: WDRS with Wall and Window Test Sample

Various mitigation strategies such as taping over the weep holes were trialed. The only configuration that greatly reduced the amount of water ingress was by using a strip of plastic sheet taped on the inside of the window sill (i.e. outside of WDRS). This strip of thin plastic increased the height of the window sill, caught the water and allowed it to drain back out of the house via the weep holes. Figure 6 shows results side by side during a pressure peak of a fluctuating pressure trace. A significant amount of water is being pushed through the seals and over the sill of the window on the left side, while the water is constrained by the plastic lining on the right side. This was a similar result for the sliding door tests.
